Subject: Status Report for the Oak Woodland Habitat Revegetation/Mitigation Program for the Santa Anita Dam Riser Modification and Reservoir Sediment Removal Project, Los Angeles County, California

Status Report: Oak Woodland Habitat Revegetation/Mitigation Program;
 Santa Anita Dam Riser Modification and Reservoir Sediment Removal Project

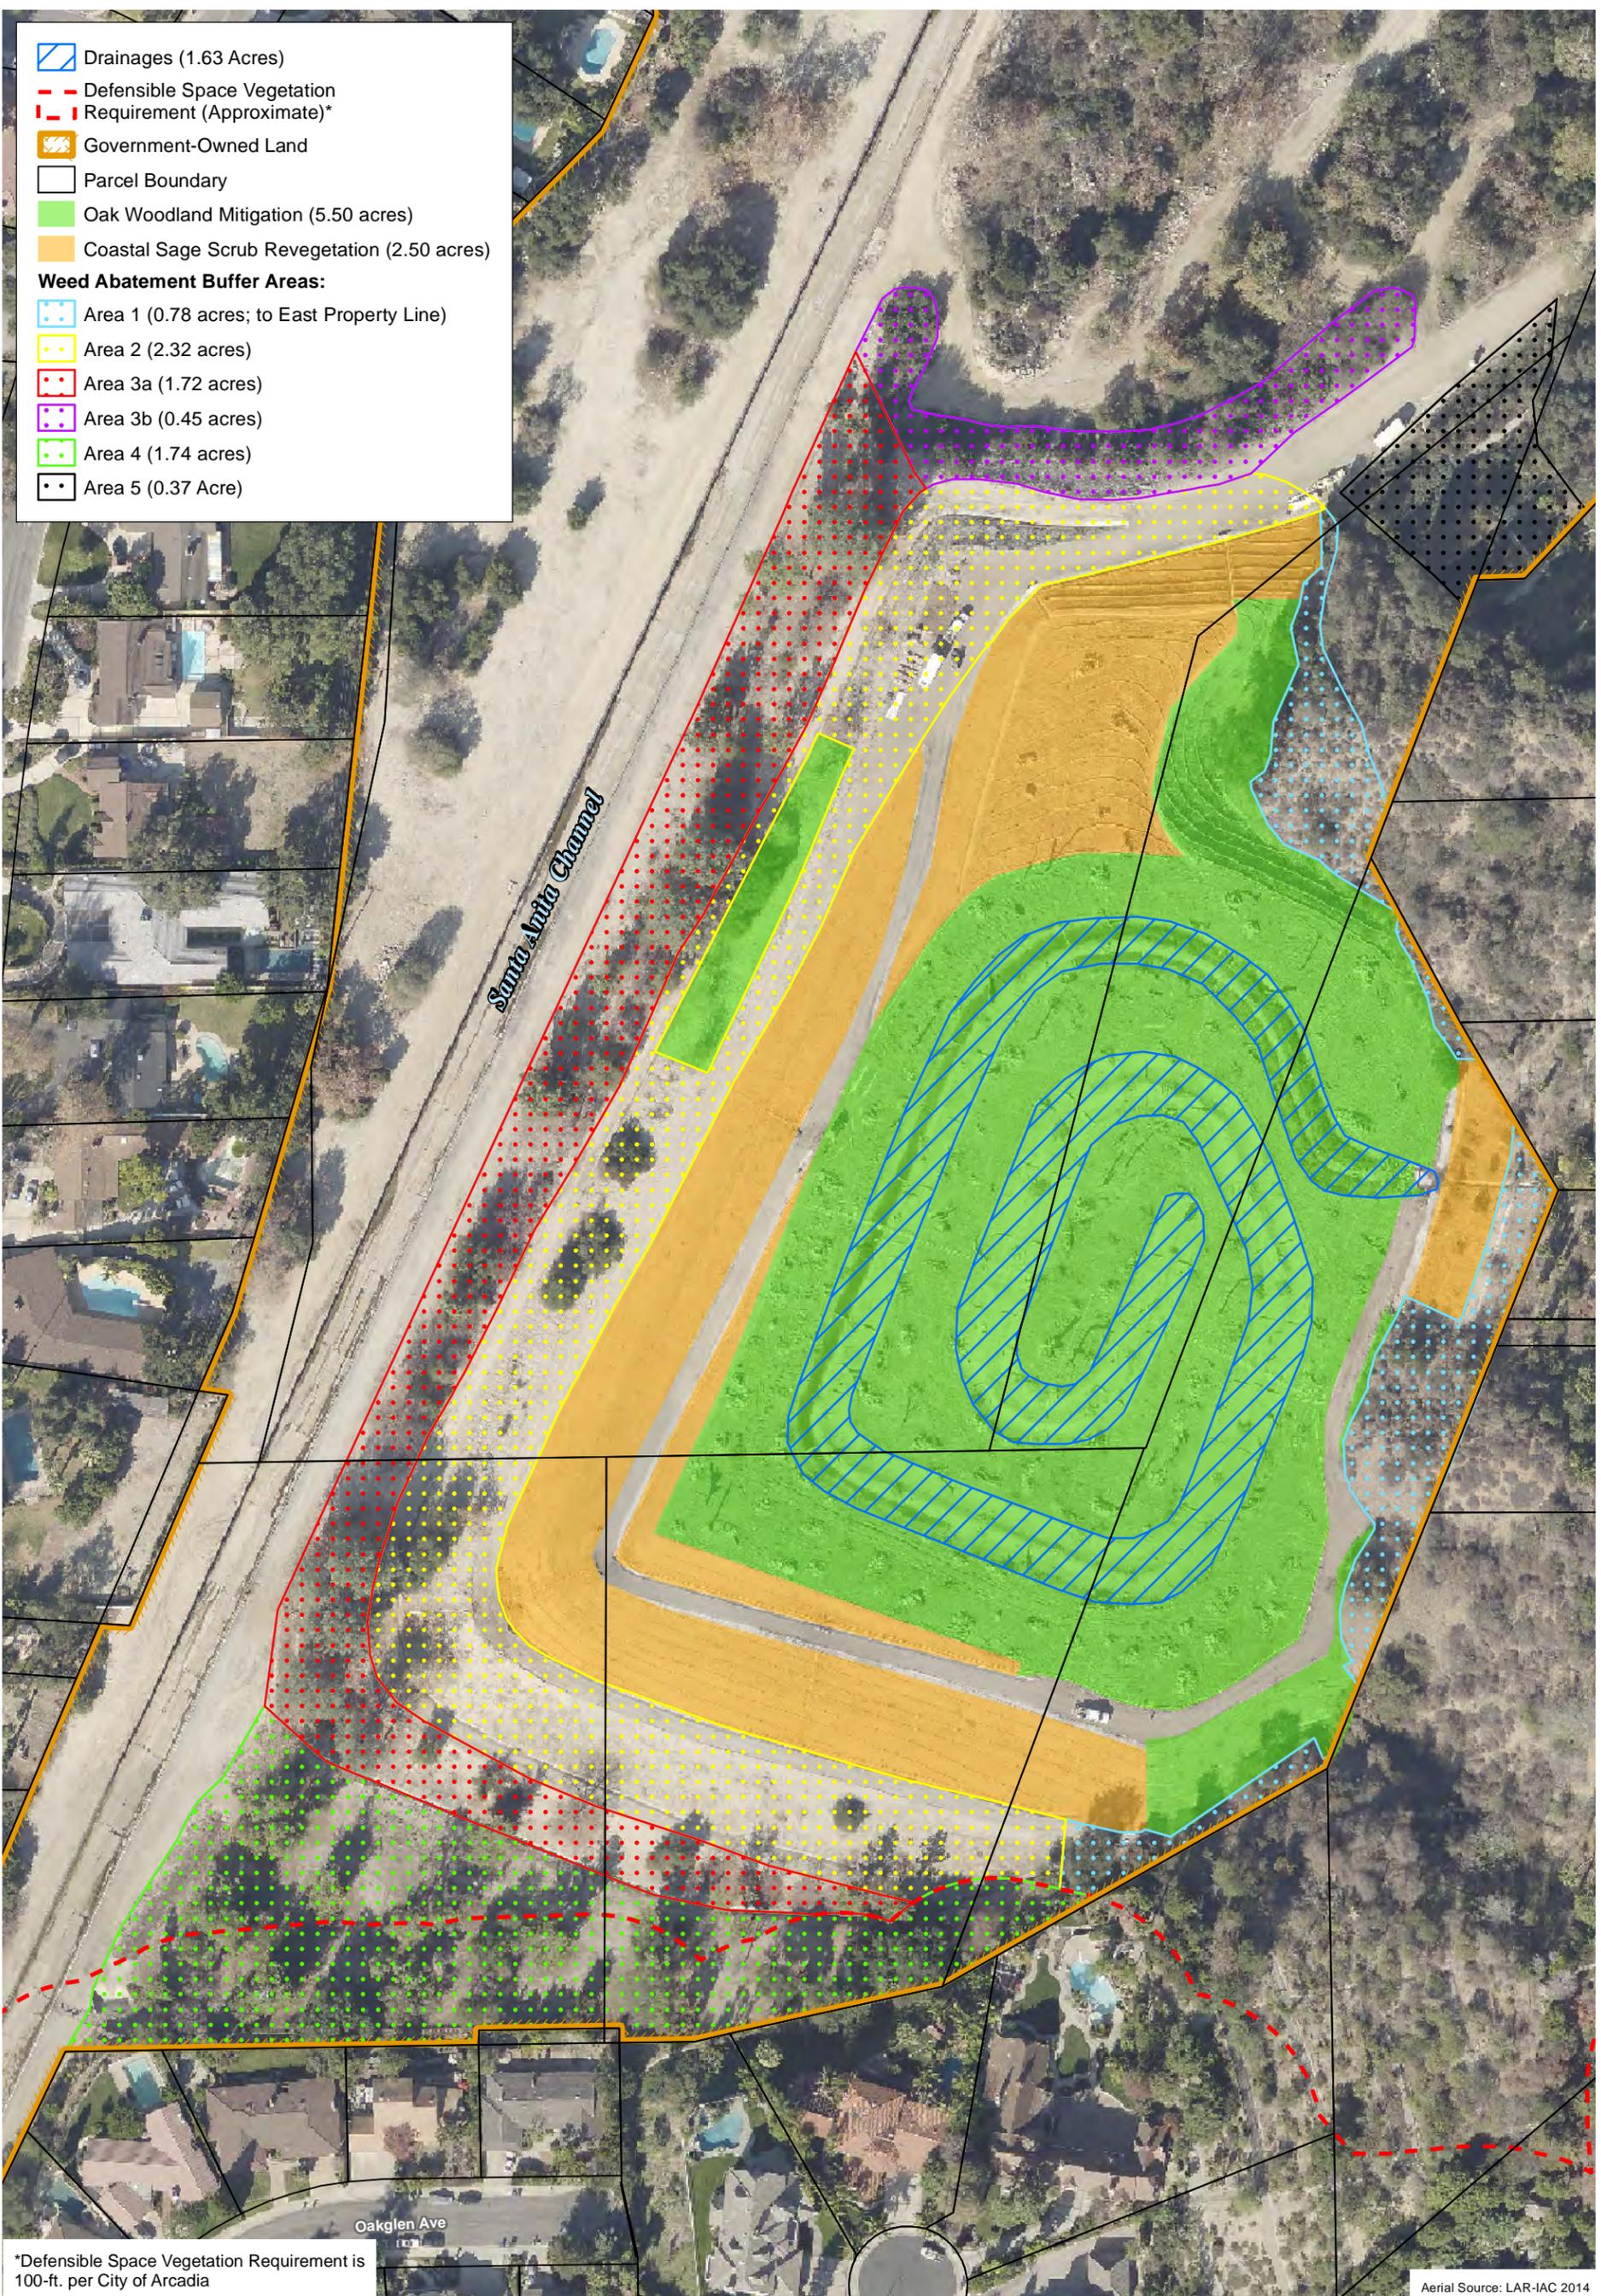
Exhibit 3

Mitigation Site Location (Lower Sediment Placement Site)

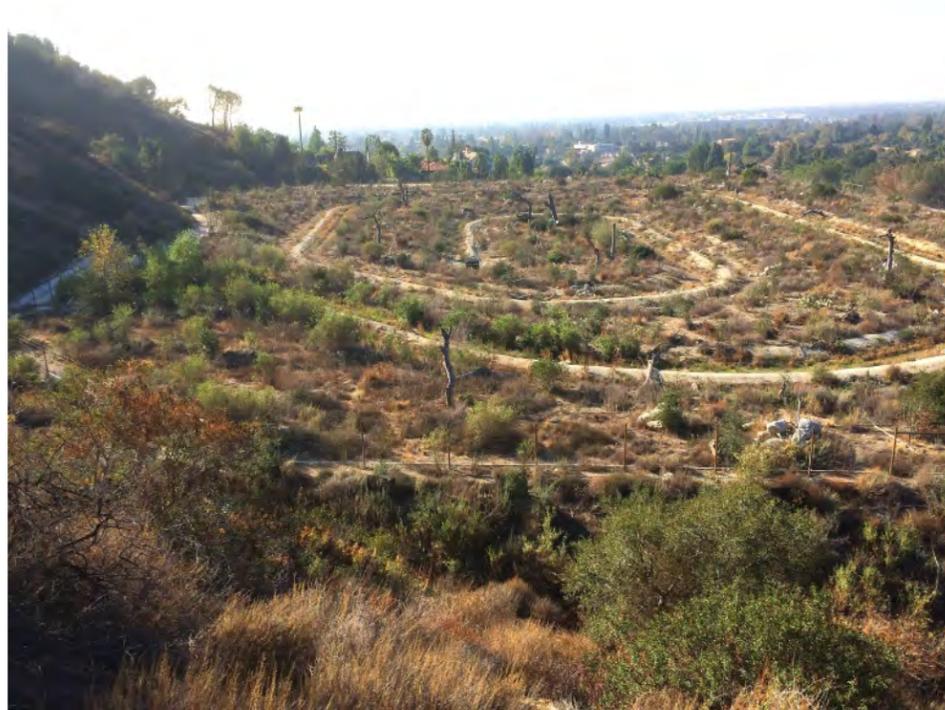
November 2018. View from north to south of the oak woodland mitigation site on the Lower Sediment Placement Site (SPS).

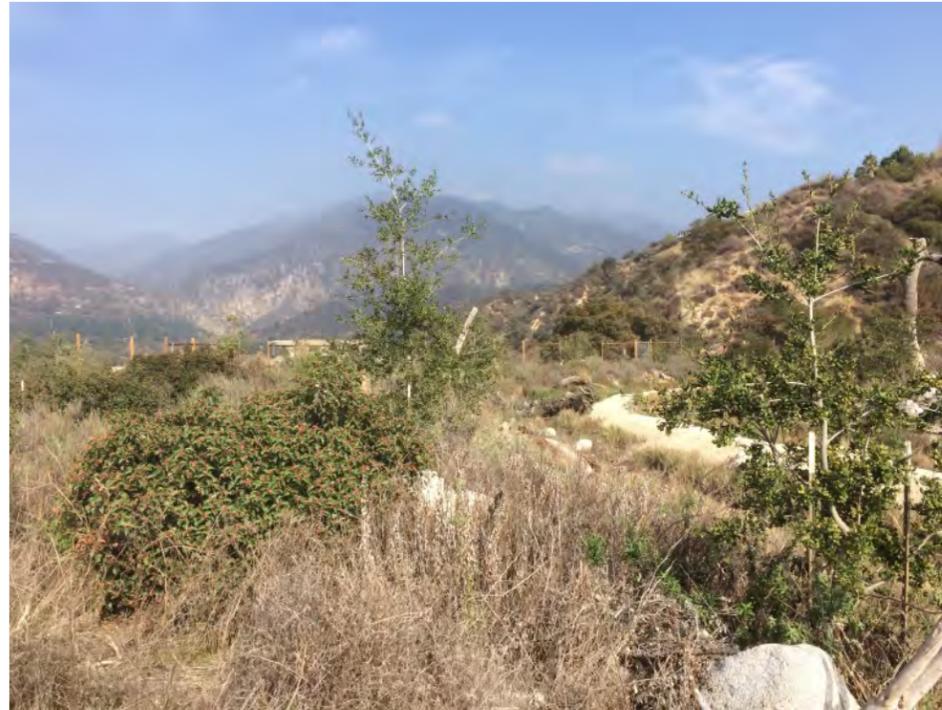
December 2018. Robust growth and healthy condition of planted coast live oak saplings, growing amid native shrubs and perennials that still exhibit drought-dormancy.

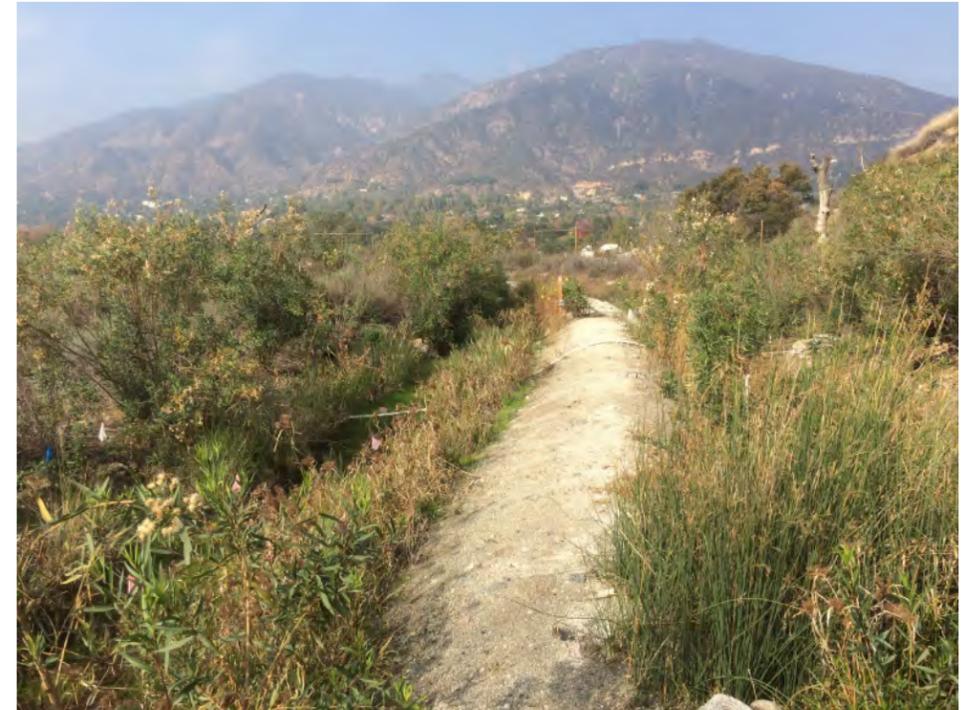
December 2018. There is dense growth of native riparian vegetation along portions of the dual, spiraling drainages that traverse the oak woodland mitigation site.

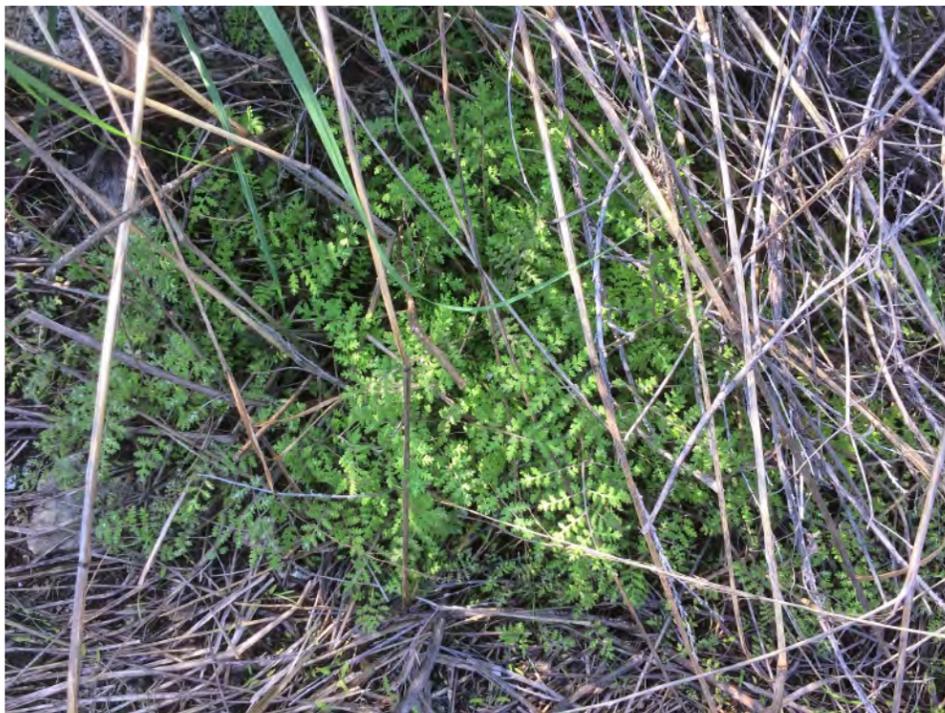
December 2018. New seedlings of distant phacelia, a re-propagating seed mix species, have emerged in response to recent rains.

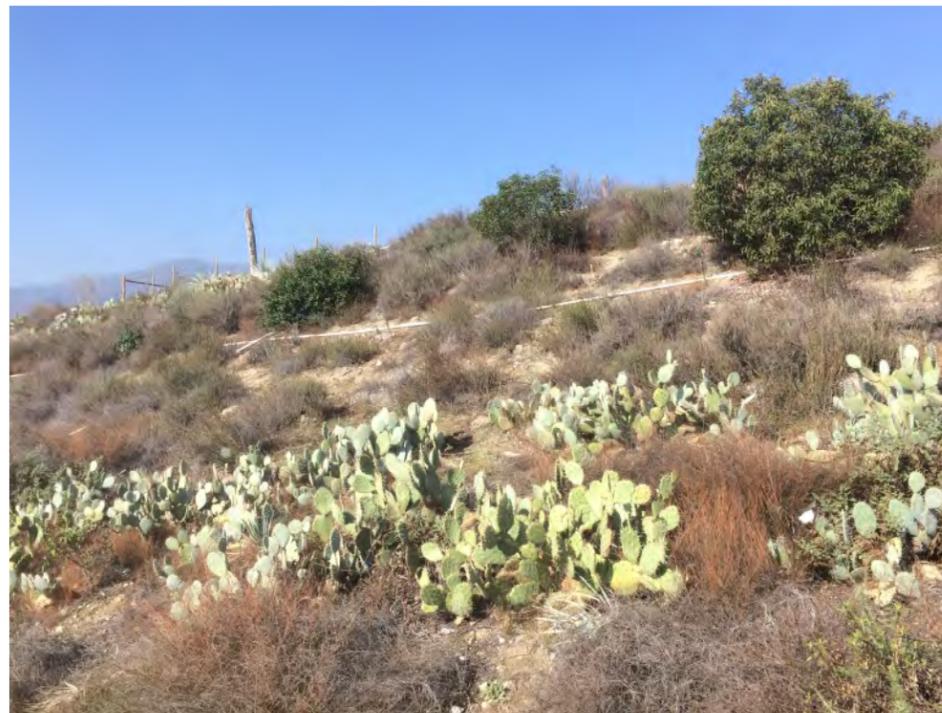
December 2018. The coastal sage scrub mitigation site includes areas that were planted with spiniferous species (cactus and yucca) to improve vegetative diversity.

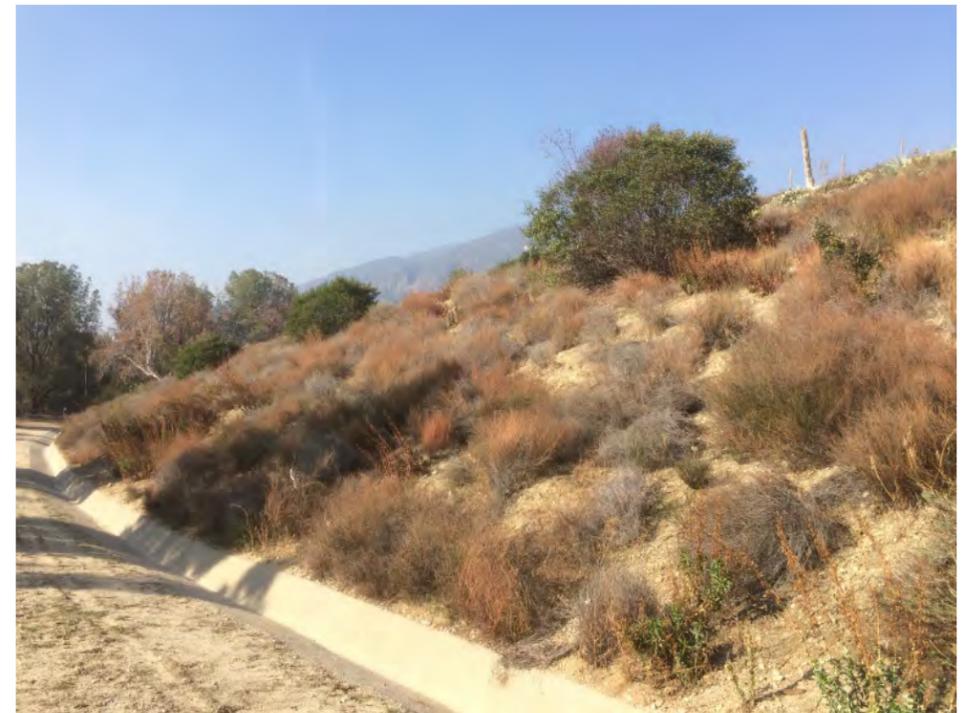
December 2018. Native vegetation is becoming increasingly abundant in the Weed Abatement Buffer Areas that Public Works voluntarily maintains and enhances on the Lower SPS.

The Restoration Contractor (Nakae & Associates, Inc.) (Nakae) promptly treats or removes non-native plant species when observed during regular maintenance activities. To the extent practicable, weeds are removed prior to seed production/dispersal to avoid re-infestation of the site. Herbicide use is minimized in favor of hand-pulling of weeds whenever possible. Nakae also performs regular maintenance of the concrete drainages and inlets on the Lower SPS, the exclusionary fencing on the deck of the Lower SPS, and the wildlife 'drinker' tanks that were placed at the northeast corner of the site. Nakae initiated maintenance of an additional Weed Abatement Buffer Area (Buffer Area 5; 0.37 acre) that is adjacent to the Lower SPS in September 2018.
